**CHALLENGES IN THE CONSTRUCTION OF A LINED VALLEY FILL
COPPER LEACHING FACILITY SILVER BELL MINING, LLC –
MARANA, ARIZONA ⁽²⁴⁾**

Nancy Johannesmeyer¹, Scott Bohman²

¹Asarco LLC 5285 E. Williams Circle Suite 2000, Tucson, AZ 85718
(njohannesmeyer@asarco.com), ²EMC 745 East Maryland Avenue, Suite 114
Phoenix, AZ 85014

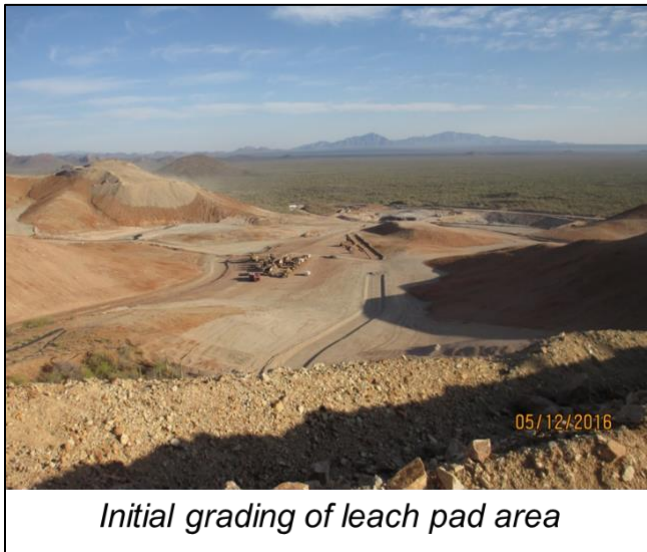
Despite extensive design and technical review, unanticipated challenges were encountered during the construction phase of the project. Construction challenges included the placement of liner on steep slopes during summer. Small wrinkles in

the liner would expand and contract causing liner slippage prior to placement of ODF to provide stability. Liner tension was experienced necessitating an alternative method of anchoring the liner and placing of ODF on slopes. Selection of material to be used as ODF had to be non-degrading in the presence of acid to maintain structural support of solution collection piping. To alleviate concerns of heavy equipment puncturing or tearing the liner, a leak location survey was performed over the entire lined area of the leach pad. This survey accurately

Probably the greatest challenge encountered during the construction of the facility was the unanticipated movement of the liner down the slopes prior to anchoring with ODF. The liner installation phase of the project started in June 2016. During the day, the liner would heat up to temperatures in excess of 77°C. Changes in temperatures caused high expansion (due to heat) and contraction (due to cooling). Air pockets under small wrinkles in the liner would

expand during the day and cause wrinkles that were larger than acceptable as well as cause a “trampoline” effect near the top of the slope. This “trampoline” effect

reduced the amount of geomembrane in contact with the GCL. Because the liner was secure in the anchor trench, the air expanded in the heat in between the GCL and geomembrane which reduced the surface contact needed to stay within the friction safety factor. When 8 cm diameter holes were cut in the geomembrane, significant amounts of hot, high pressure air was observed escaping out of each hole. At night the wrinkles would cool and contract further down the slope causing the liner to creep down to the toe of slopes. In as little as 3 days, all excess liner was at the toe of the slope and the liner anchored at the top of the slope was in tension, a condition that will cause liner failure. Due to the contractor’s work phasing and the lag in crushing/screening of ODF material, lined slope areas initially sat uncovered for over a month while the expansion/contraction process continued.

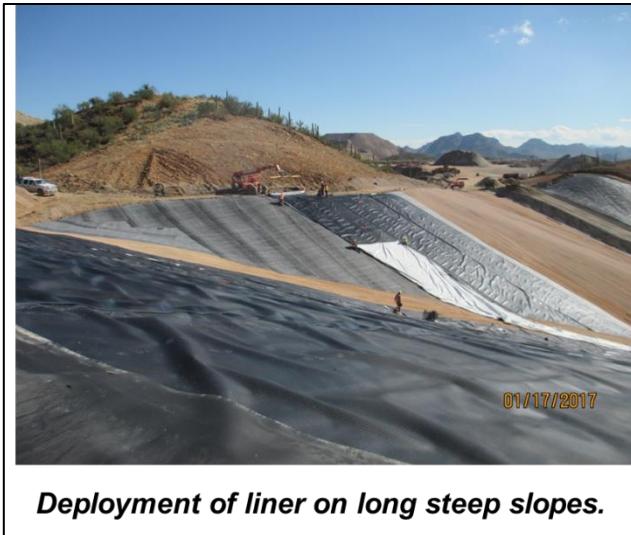
Deployment of liner on long steep slopes.

The grading design incorporated continuous slopes up to 137 m long.

Areas with slopes between 2H:1V and 2.5H:1V were necessary to optimize the

The original design called for LLDPE liner rolls up to 137 m in length for placement on long slopes as steep as 2:1. Due to slope geometry, the liner design was modified to include mid slope seams. Concerns with this design included reduced strength at horizontal seams on end-to-end LLDPE panels going up slopes, and long slope lengths without benches to break up the loading. To the extent possible, horizontal seams were minimized on slopes, and if installed, were staggered from adjacent panels' seams. Due to the rolling nature of the slopes, angled seams and horizontal seams could not be avoided entirely. The long 137 m design slopes were re-designed to be shorter and flatter to minimize the long panel lengths and to minimize the potential for liner movement during ODF placement.

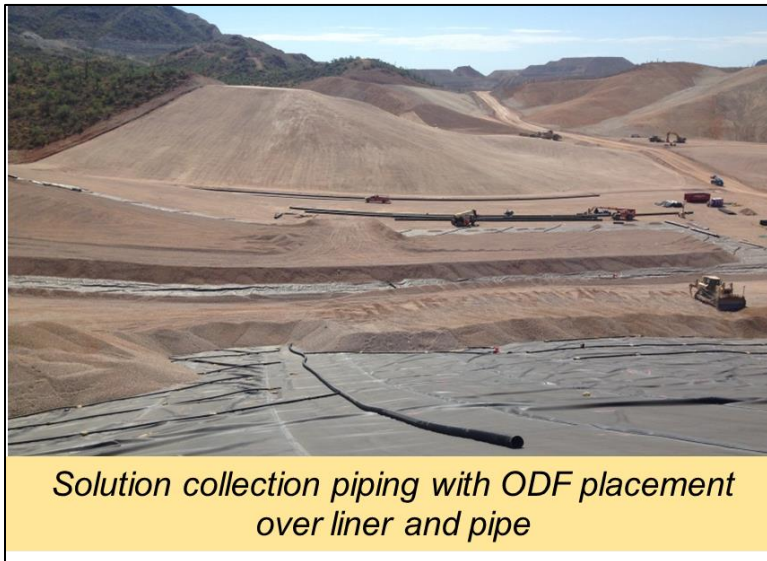
Solution collection piping with ODF placement over liner and pipe

The purpose of ODF to protect the solution collection piping system and LLDPE liner from damage during placement of ore and for the life of the pad with ever increasing loads. A suitable source of ODF needed to be acid resistant

to prevent breakdown over time causing external loading support loss on the collection pipes, and pipe collapse. On-site pit waste rock composed of Alaskite was found to provide the best combination of acid resistance, gradation

and cost savings. Pipe Support Fill was screened from the Alaskite ODF material during crushing. At locations of collection pipe tees, eccentric reducers were included in the design to maintain intimate contact between the pipe and subgrade and eliminate voids under pipes that could create load concentration points. Geogrid fabric was also placed within the ODF over tees to provide additional strength and load distribution at structural weak points.

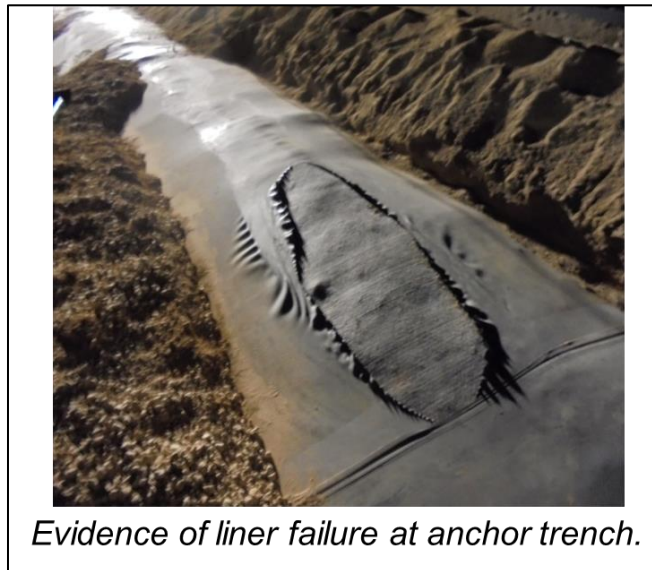
Evidence of liner failure at anchor trench.

Wrinkles in excess of 15 cm were removed prior to ODF placement. In one steep 2H:1V slope section, the liner experienced significant movement and ODF placement on steep slope sections was temporarily suspended. The liner continued to move and thinning and tension tears occurred at the top, uncovered portions of the slope. Other steep 2H:1V slope sections showed some signs of movement, but not as significant.

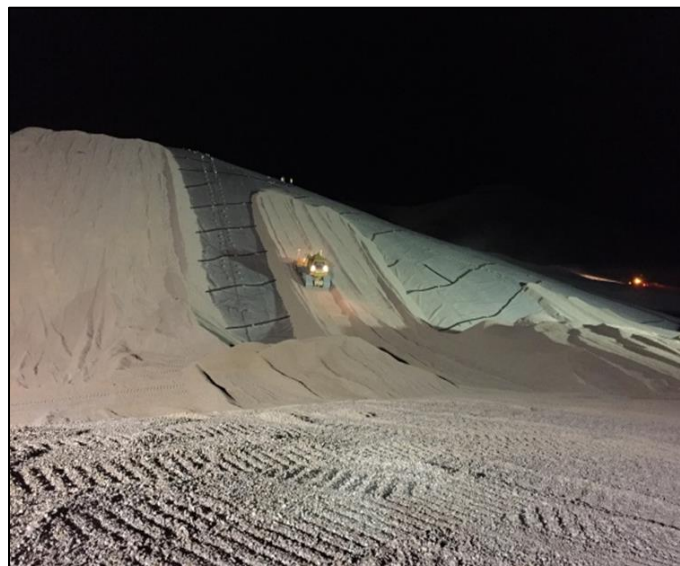
Night time ODF placement

- ODF placement at night, or with liner temperatures less than 30°C.
- LLDPE was placed using slip-sheets to prevent combing of the GCL fibers during placement.
